MACHINING

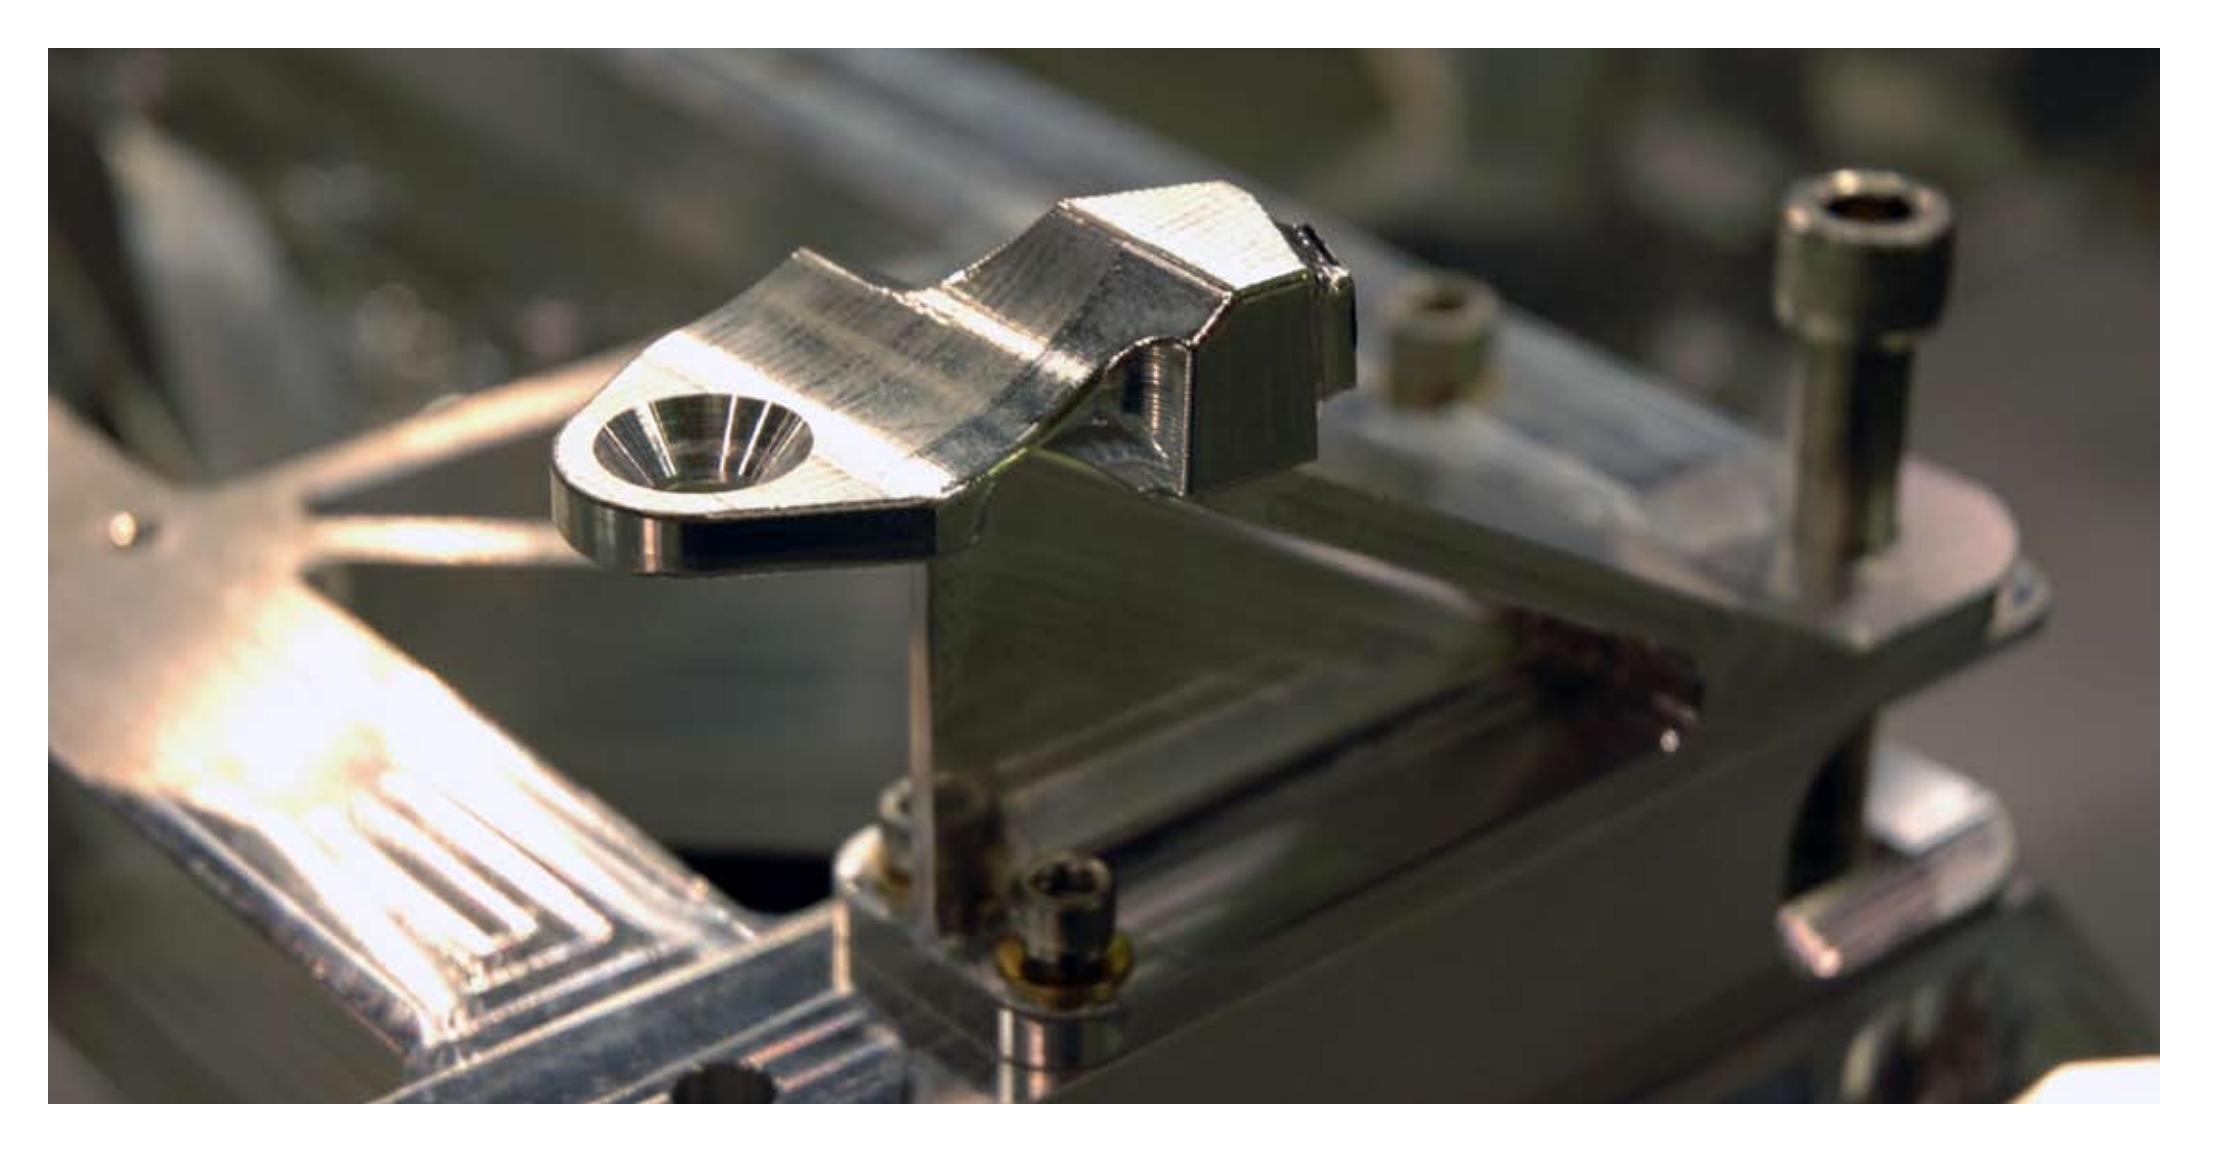
The above bracket is a stiffening brace to minimize flex of the front shock tower. We machined a dish into the top of the bracket for shock clearance. Notice the tapered hole for a flat head bolt. The area is too tight for anything else.

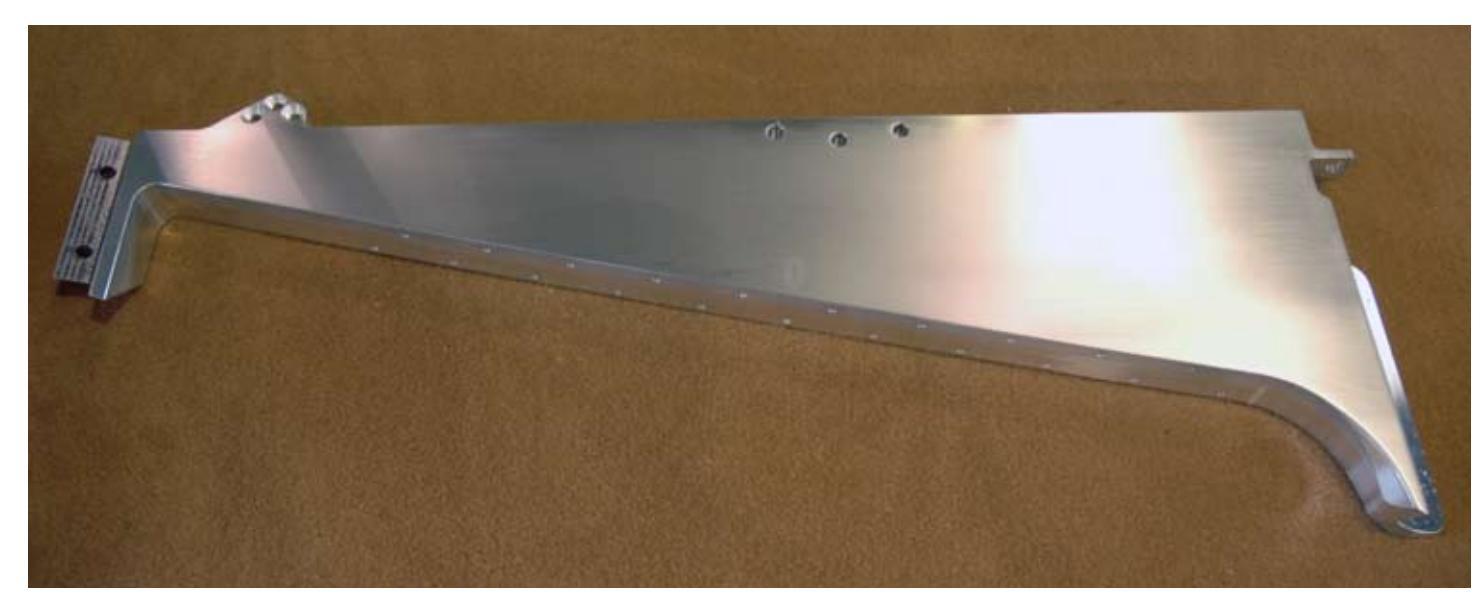
Left trunk brace. It has many different angles on it that had to be fixtured so they could be machined accurately. The "sheet metal" was milled directly into this part to save weight.

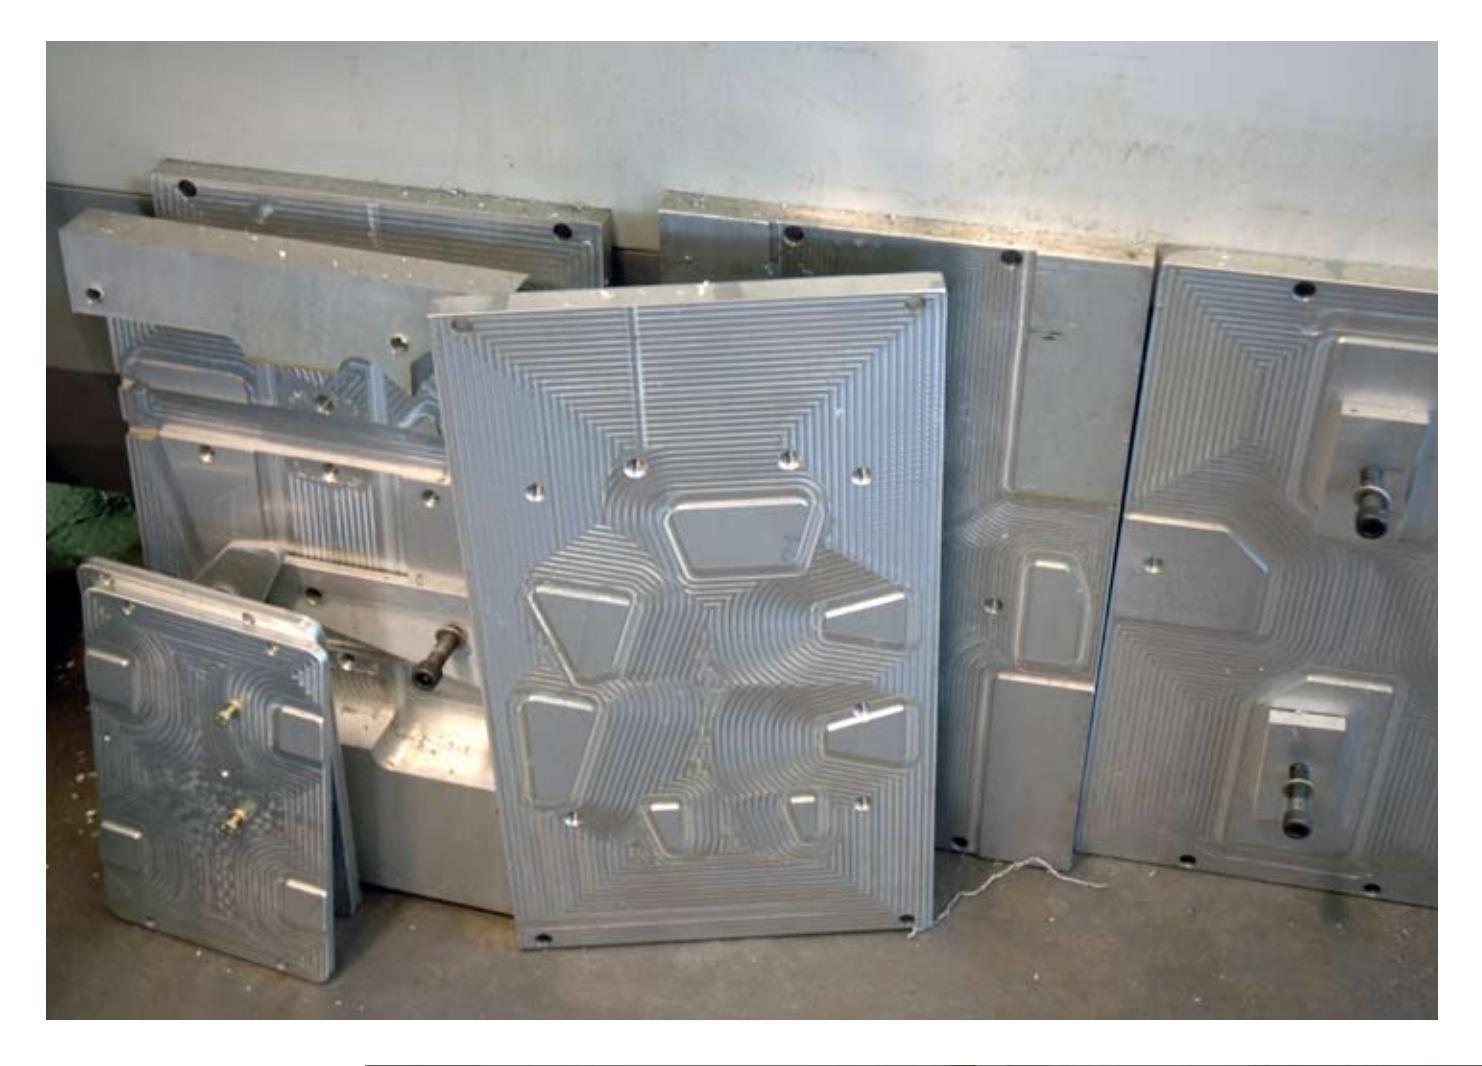
We made many different fixture plates to machine all the different angles in the parts.

Below: A fixture plate in action on the 4th axis. The 4th axis is for spinning the part around. Many parts, like this one, had to be machined on all six sides—requiring many operations.

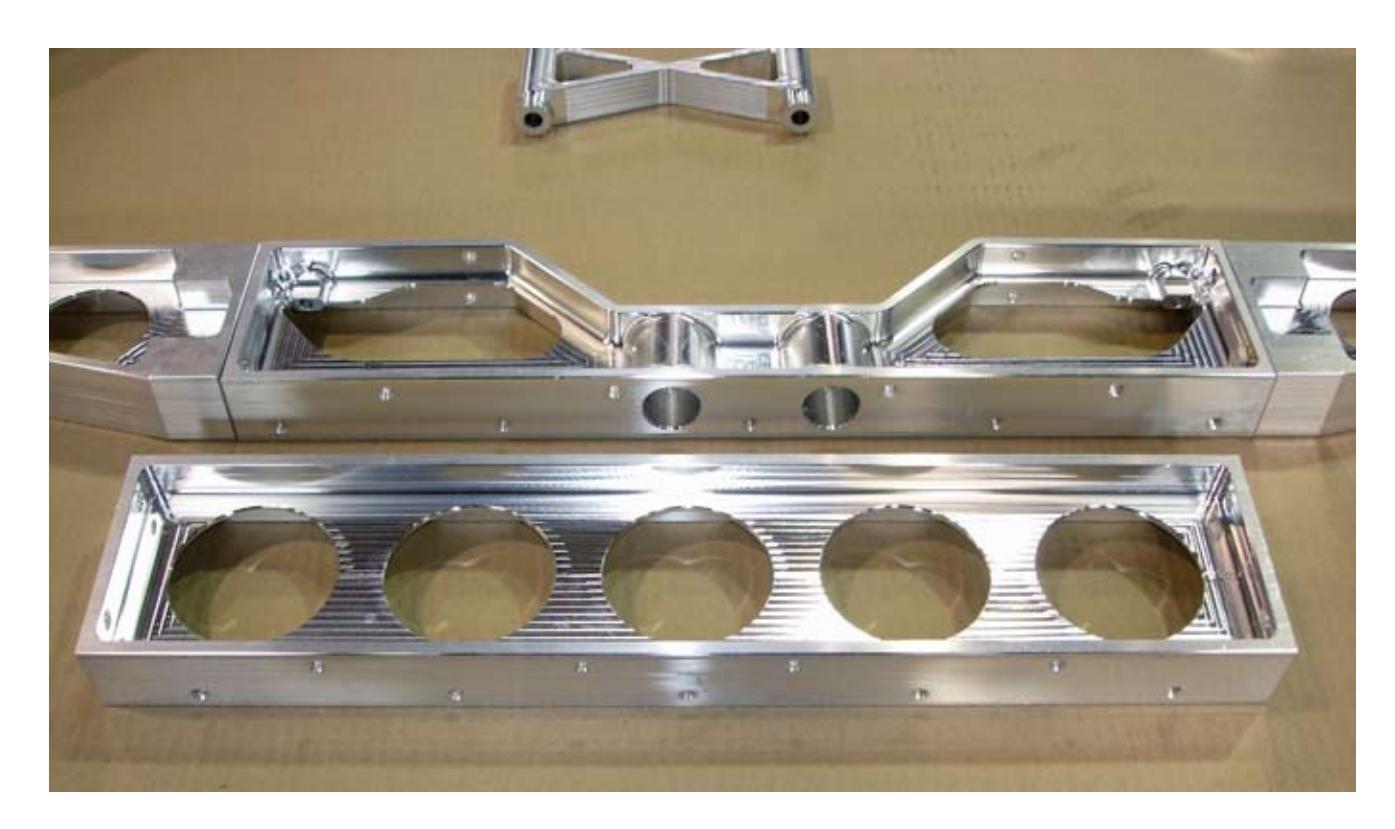
Left: The cross member in the top of the photo is recessed for the transmission mount. The cross member in the lower part of the photo goes in front of the differential. This design was later superseded when we made provisions for a drive shaft safety loop. The small, tapped holes in the bottoms of both cross members are for mounting the belly pans.

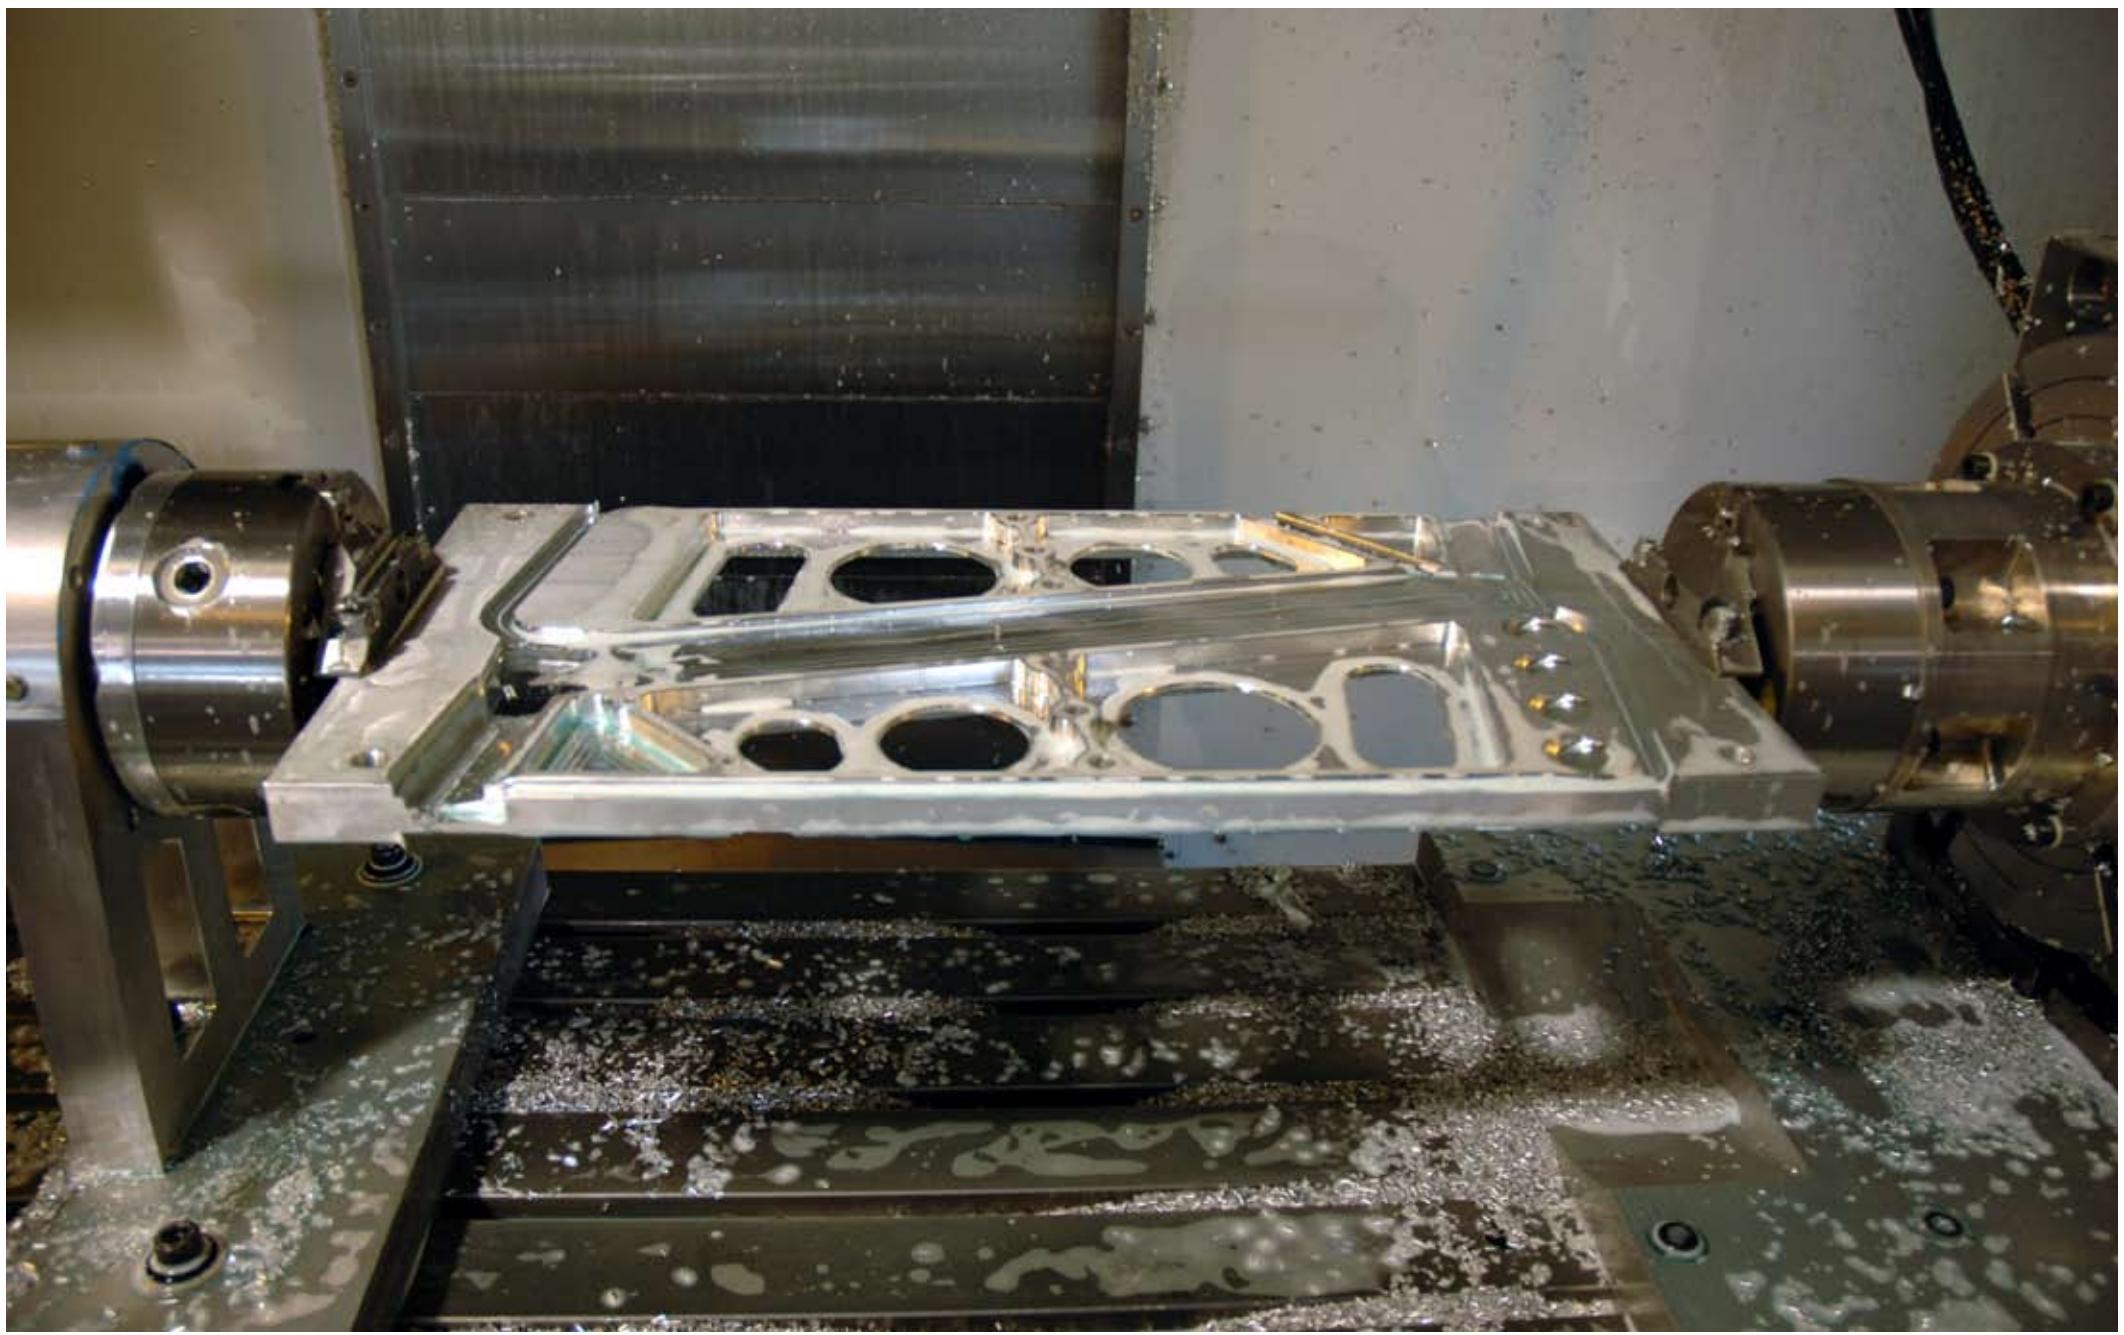
Below: The prototype's front jack hook arms that support the jack hooks and radiator—this piece too was later superseded with a lighter design.

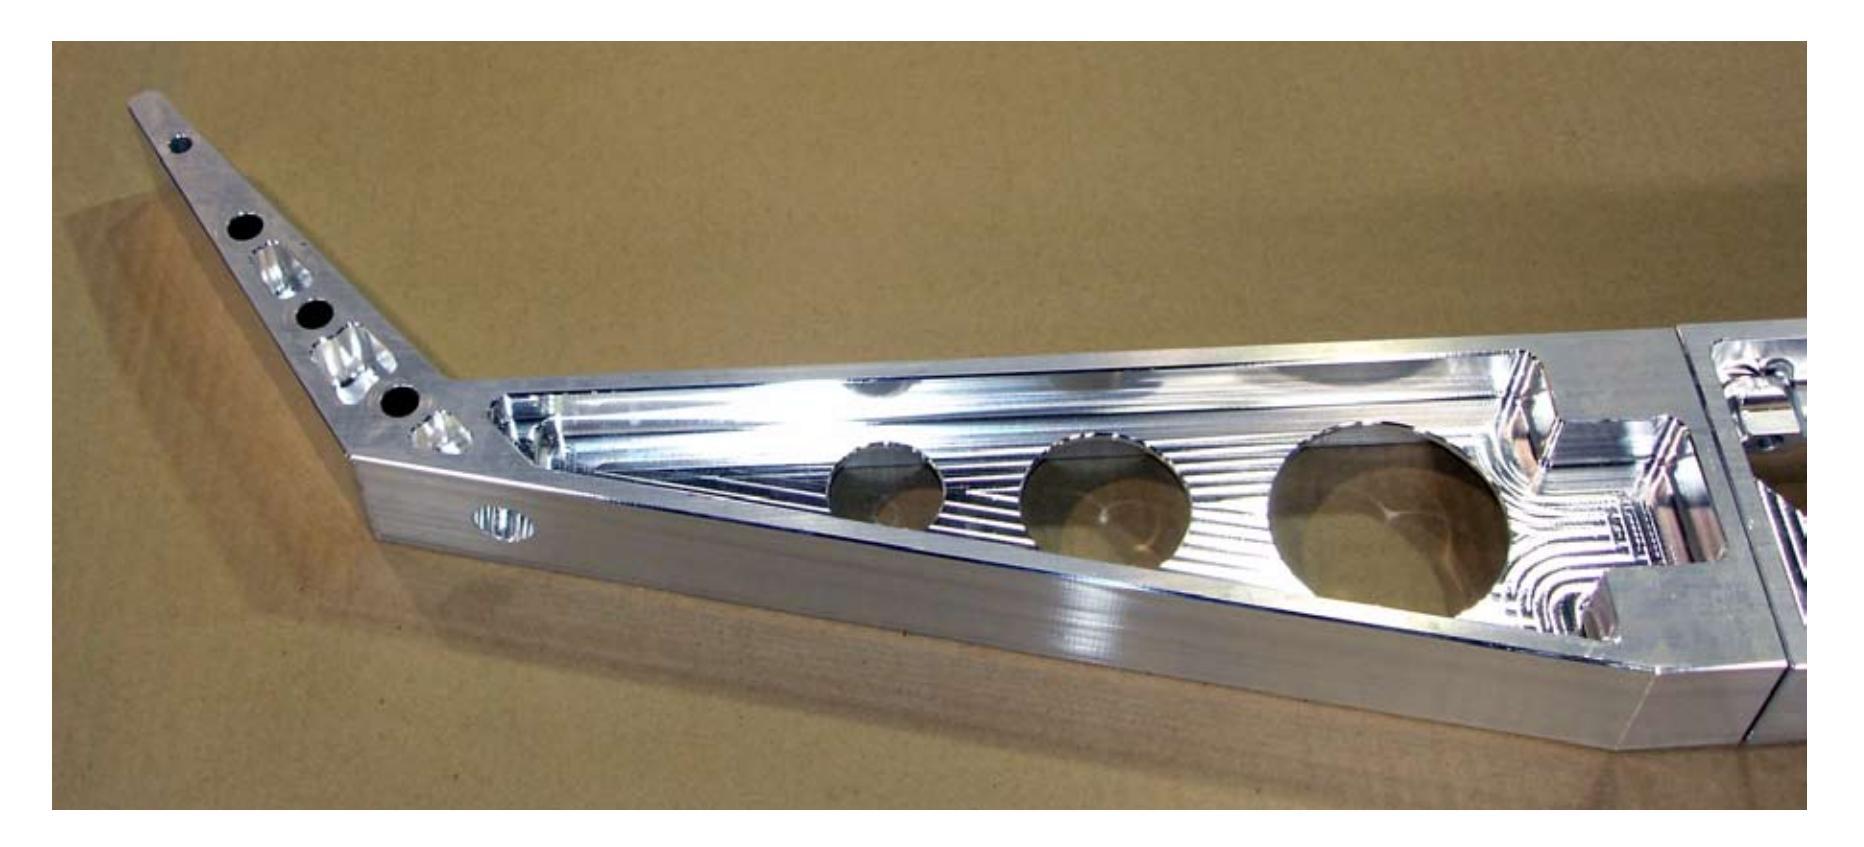
This is part of the cross member behind the passenger's seat. The sharp triangular area is where the door sill plate bolts in.

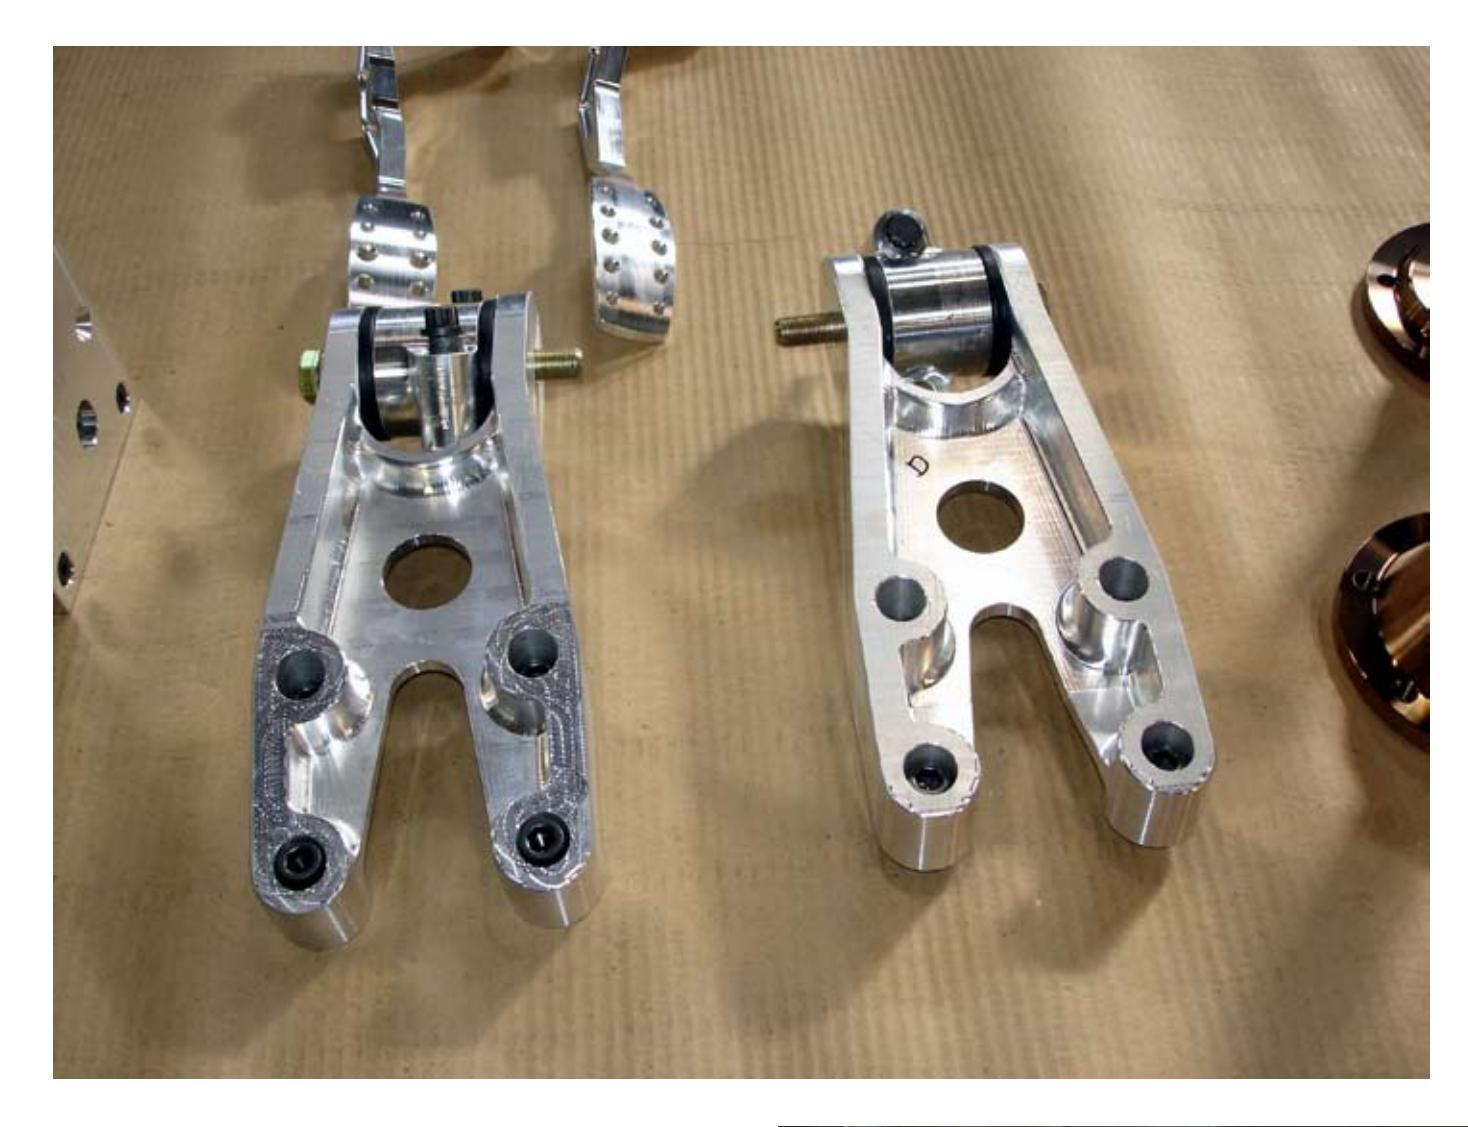
The motor mounts are a fail-safe design with through bolts to prevent the engine from breaking loose if the urethane should ever fail. The motor mounts are also quite stout with 1/2 inch walls. We have seen too many motor mounts fail in accidents.

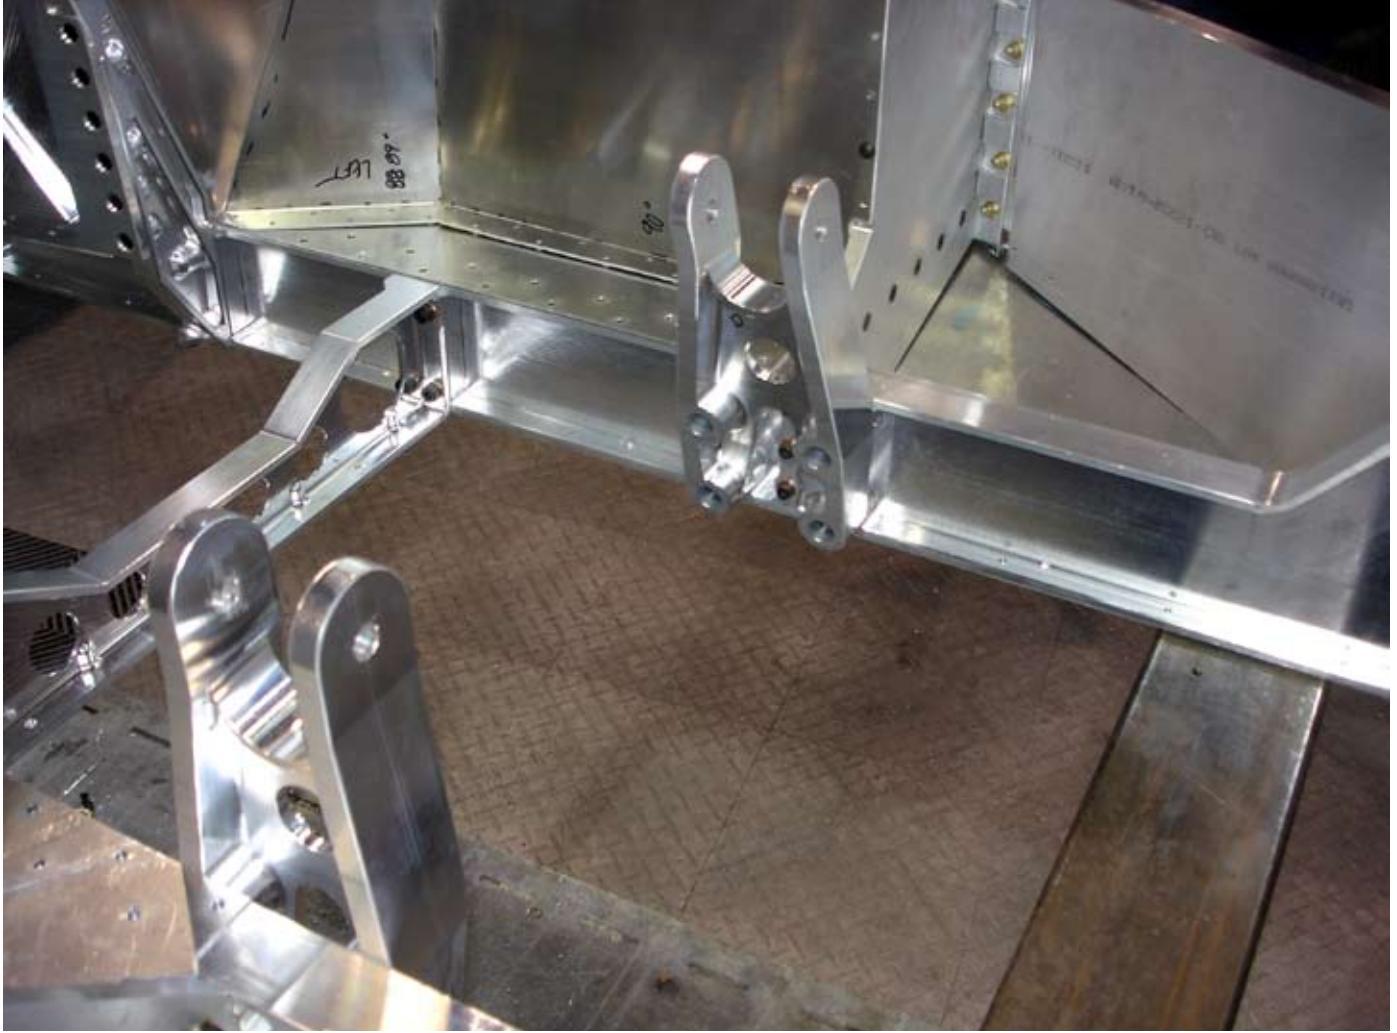
The motor mounts are designed to spread the load over the entire frame rail by tying the top and bottom of the main rail together.

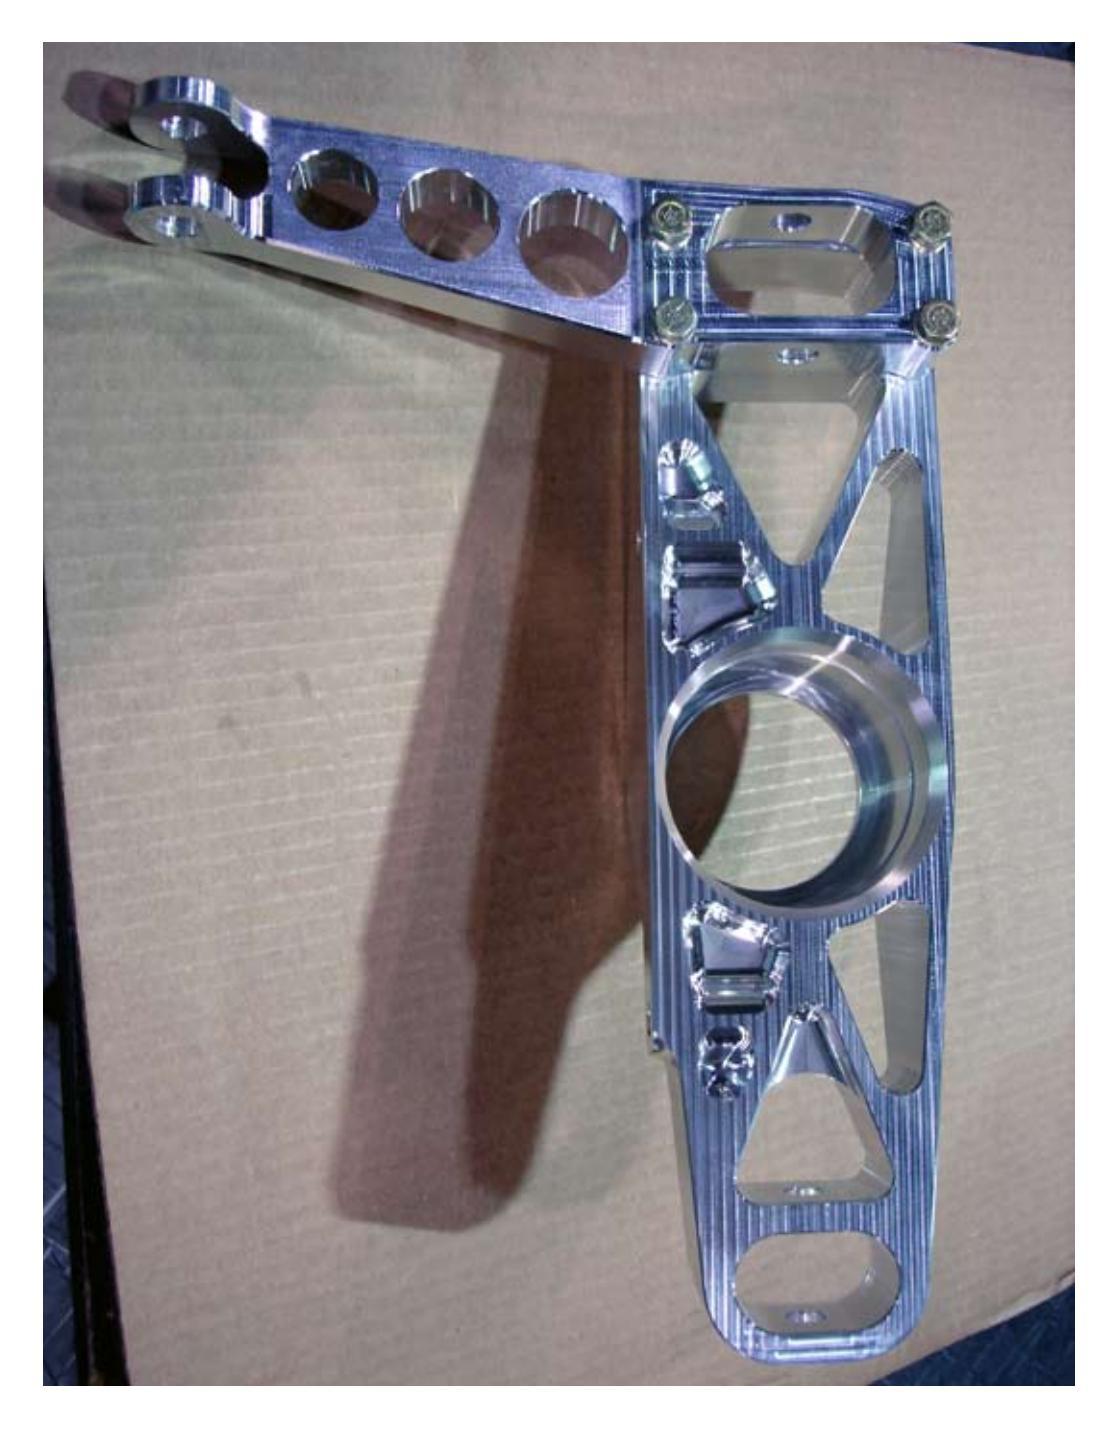
The steering arm (at the top of the upright) was designed to capture the outer tie rod in double shear to eliminate any cantilever loads on the tie rod bolt. The steering arm was later superseded by a stiffer part. The big bore in the center of the upright is for the large Lexus bearing we now use in all our cars. The bearing is rated for a life of 300,000 kilometers—in cars with twice the mass.

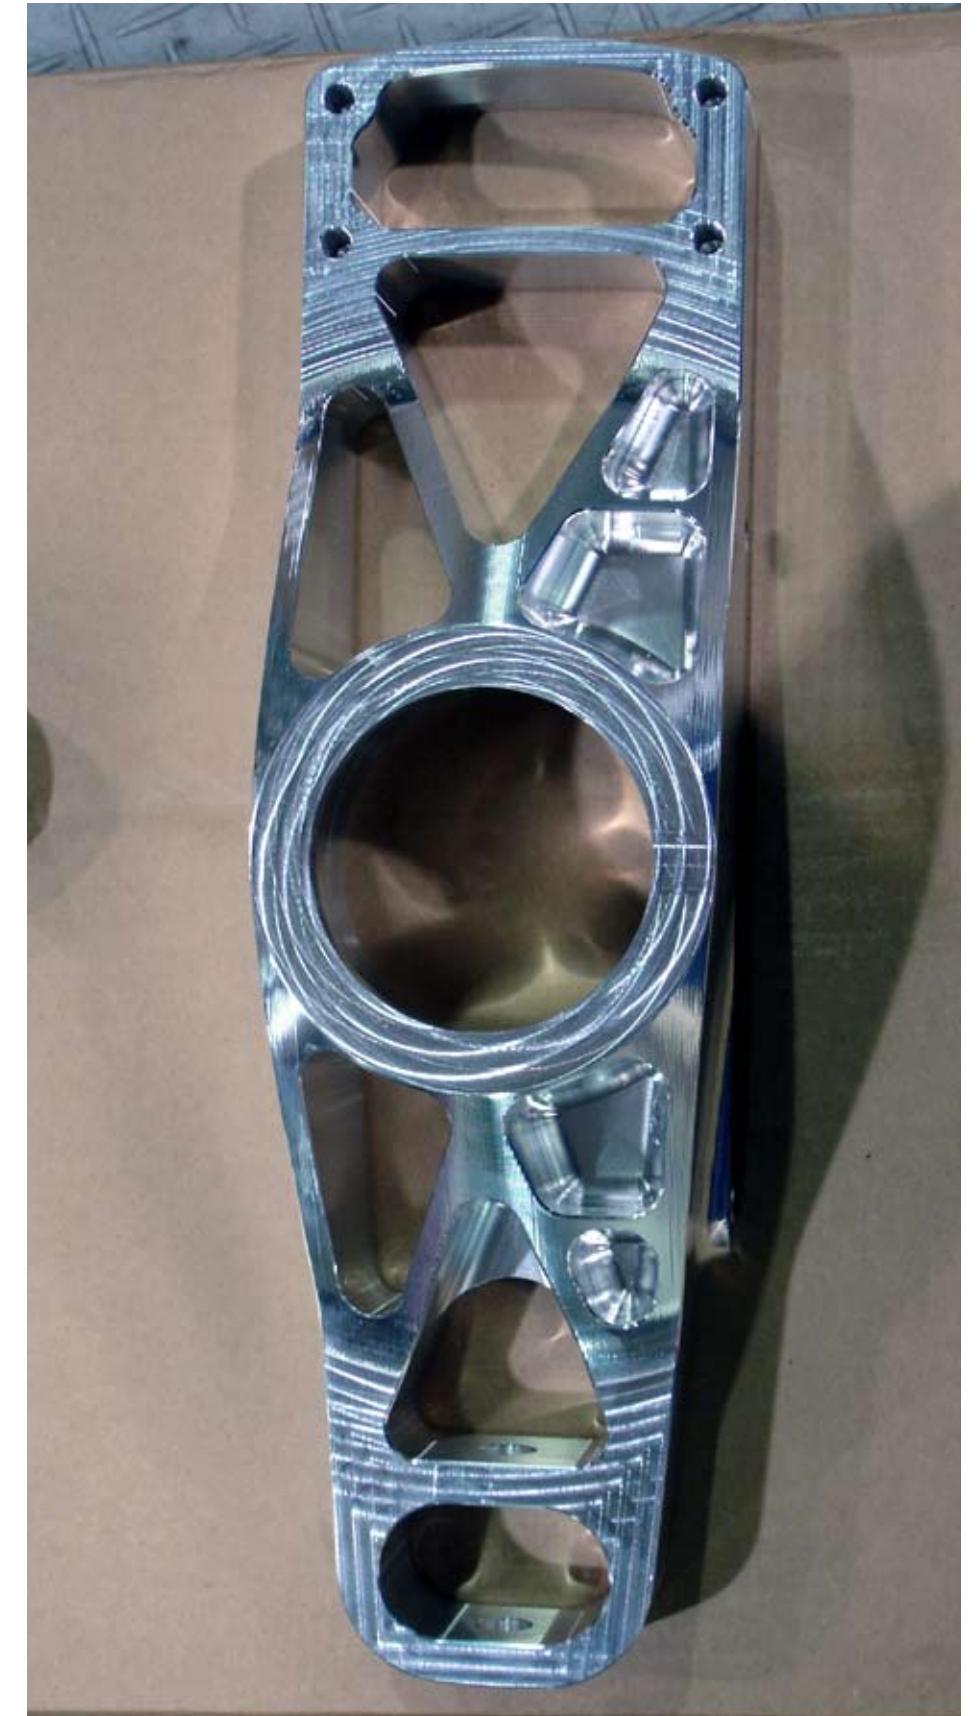
The front upright was a challenge to design with everything we wanted. Notice the upper and lower ball joints are captured in double shear. The upright is hollow to allow airflow for brake cooling. The brake caliper side of the upright is not hollow because it has to feed braking loads into the wheel bearing to stop the car.

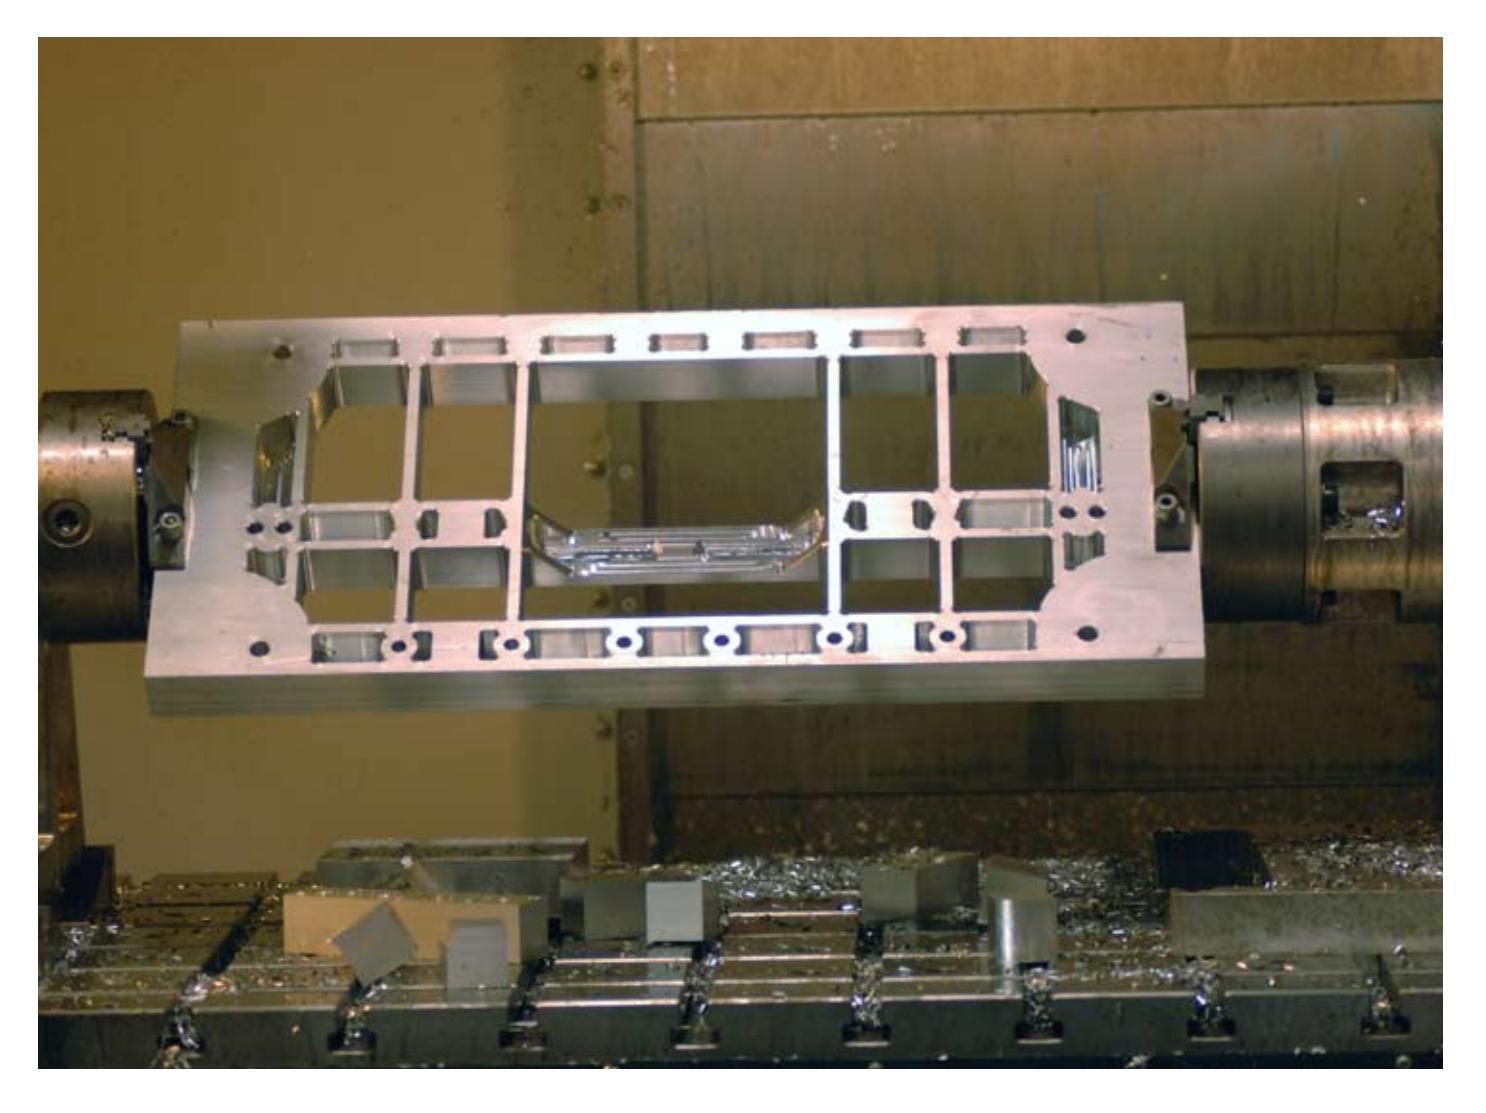
This is the top plate of the rear suspension box during manufacturing. The cut out in the center enables the plate to clear the top of the differential.

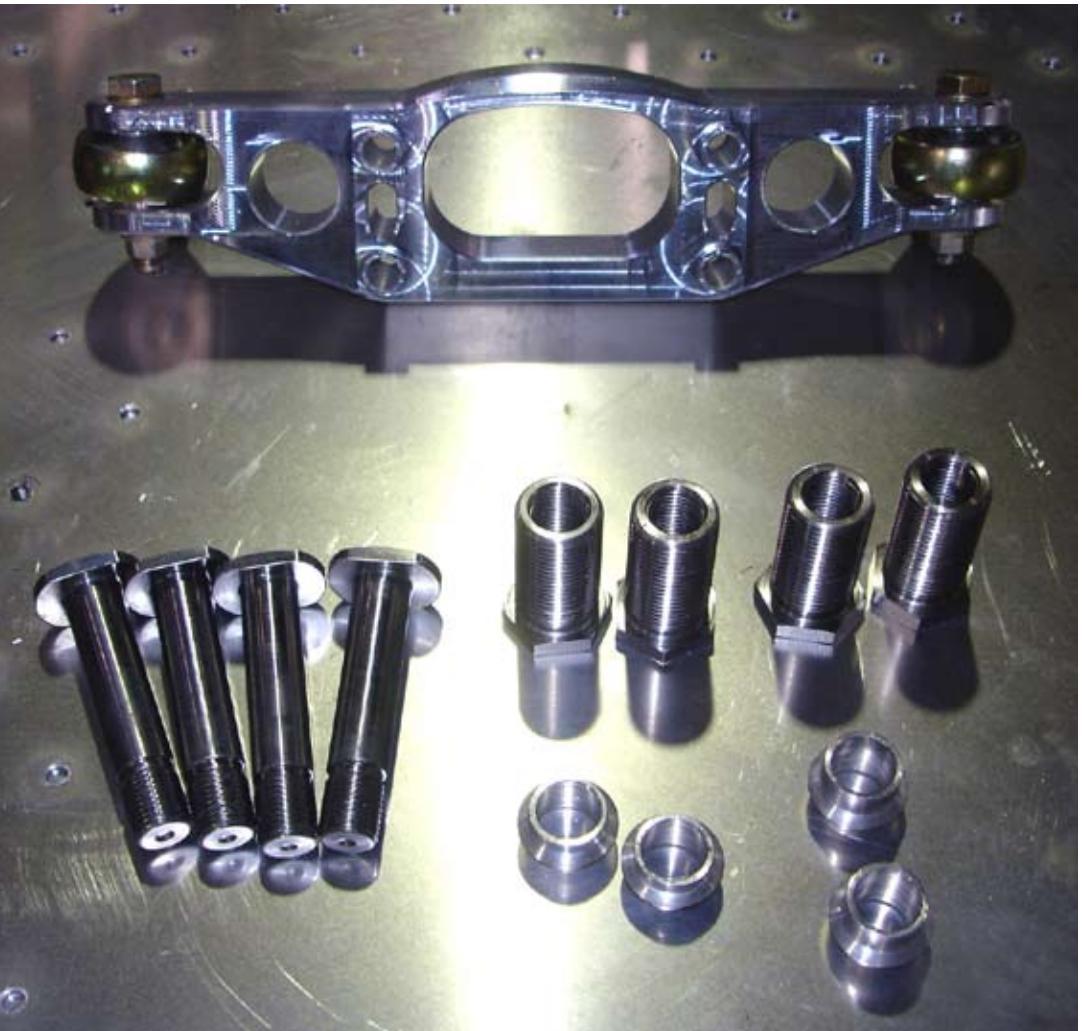
Right, top of photo: The upper bracket that connects the rear upper control arm to the rear upright. Notice the rod ends are captured in double shear. Bottom of photo: The special bolts are the pins for the upper and lower control arms. The threaded sleeve nuts are designed with external right-hand threads and internal left-hand threads to allow alignment adjustments without disconnecting the control arms. The parts are made from 17-4 PH stainless steel.
