MACHINING

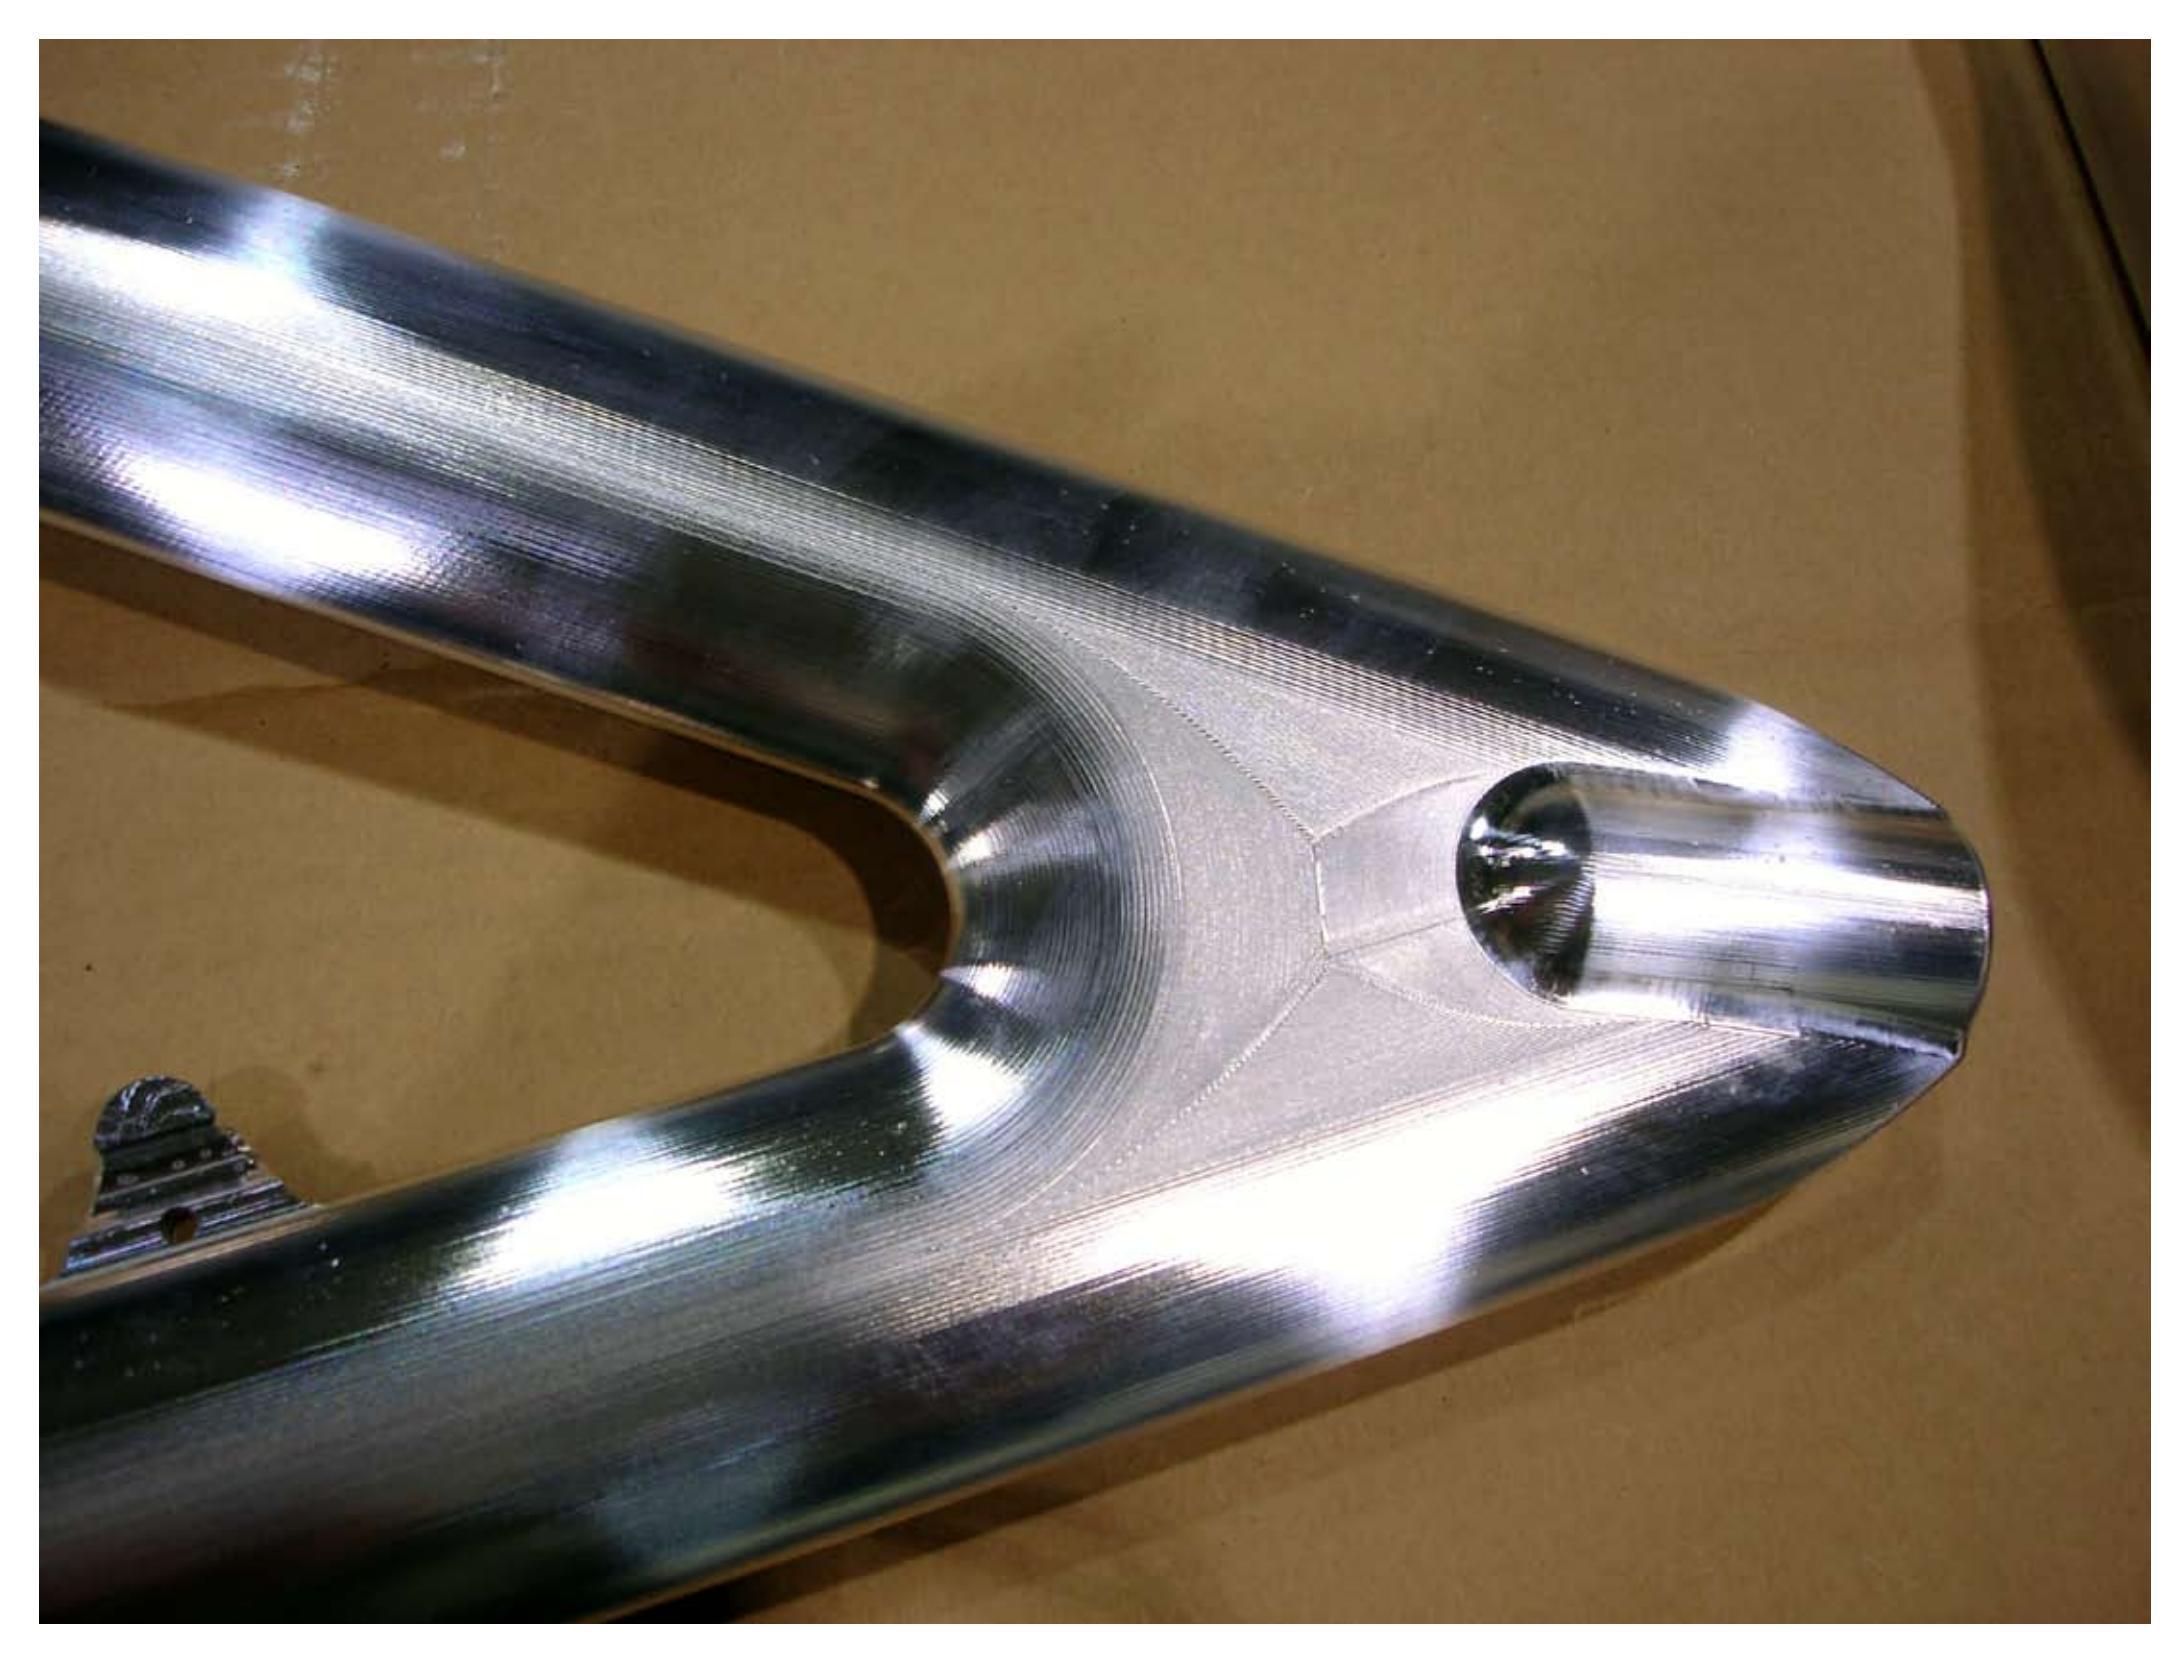
Even tiny machining marks make tiny stress risers in a part. The stresses on the above control arm are concentrated where the two legs of the control arm join. We conscientiously programmed the tool paths to run around the control arm in long sweeping arcs—without stopping—to minimize any stress risers from the machining process.

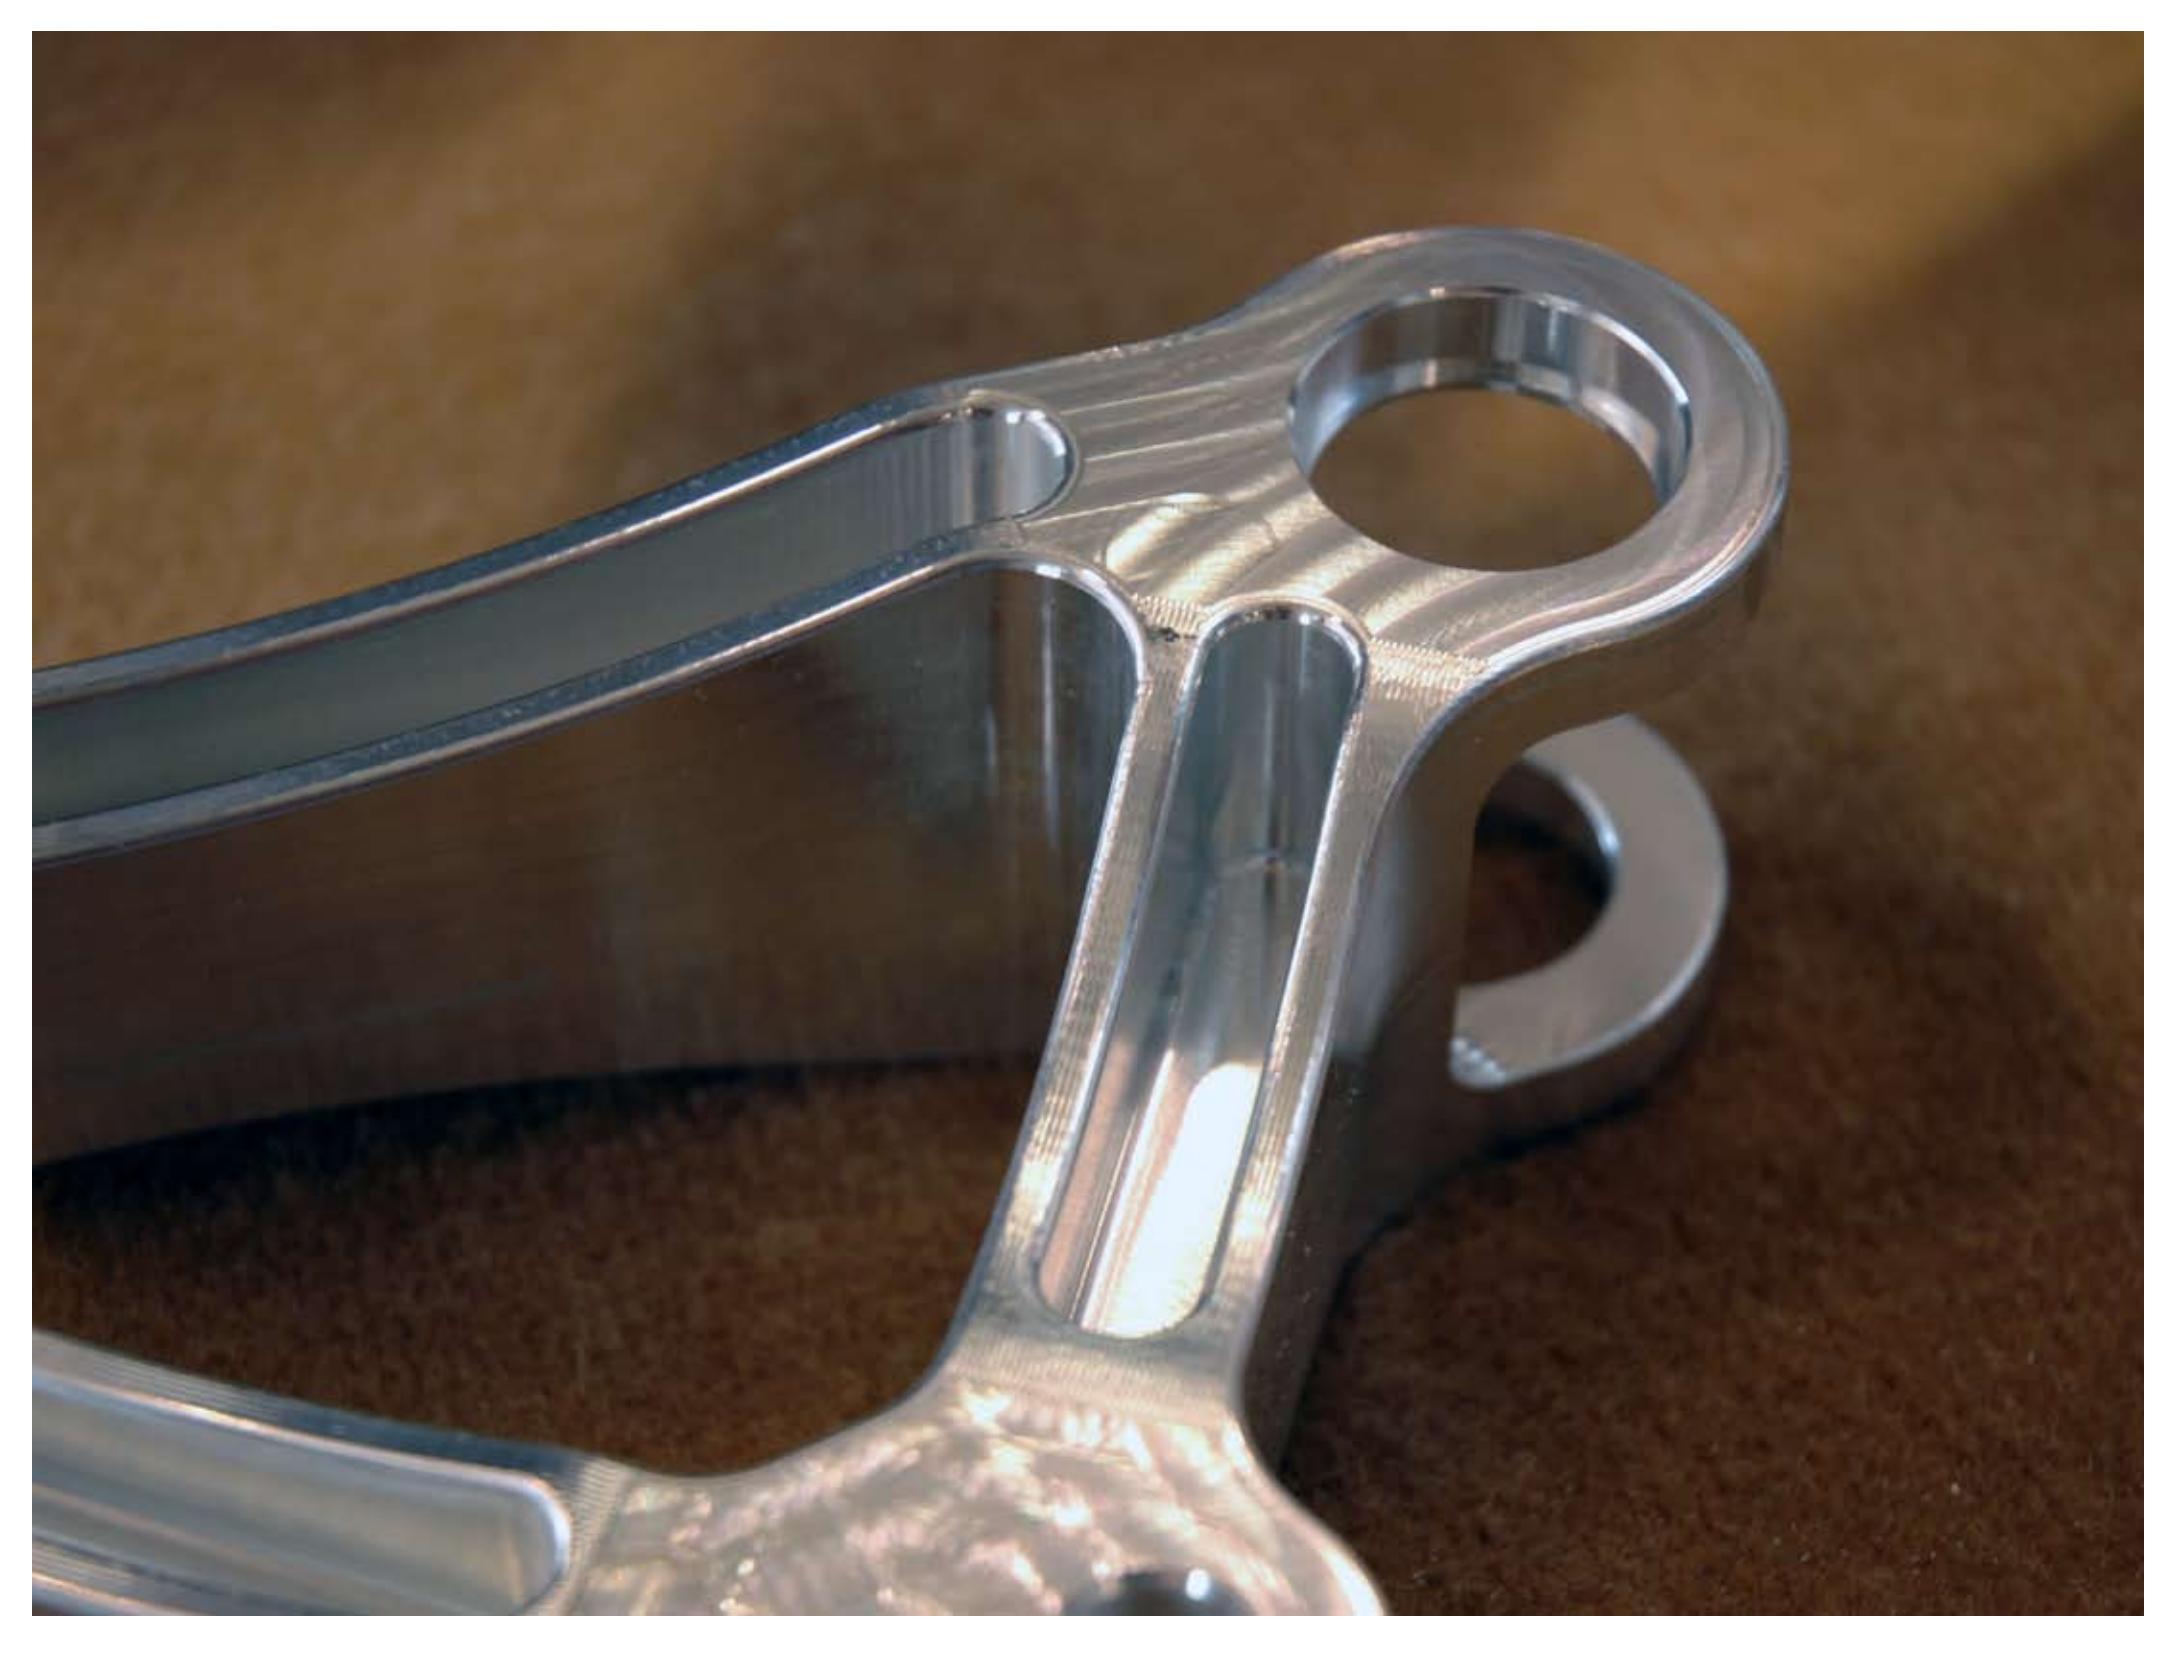
All machined parts had deburring passes painstakingly programmed into the sweeps and curves of the CNC milling paths for consistency and beauty. This is the rear shock rocker.
